SERVICE BULLETIN

| Classification: BR97-001 | Reference: NTB97-053 | Date: July 30, 1997 |

1995-97 MAXIMA PARKING BRAKE CABLE DAMAGE

APPLIED VEHICLE: 1995-97 Maxima (A32)

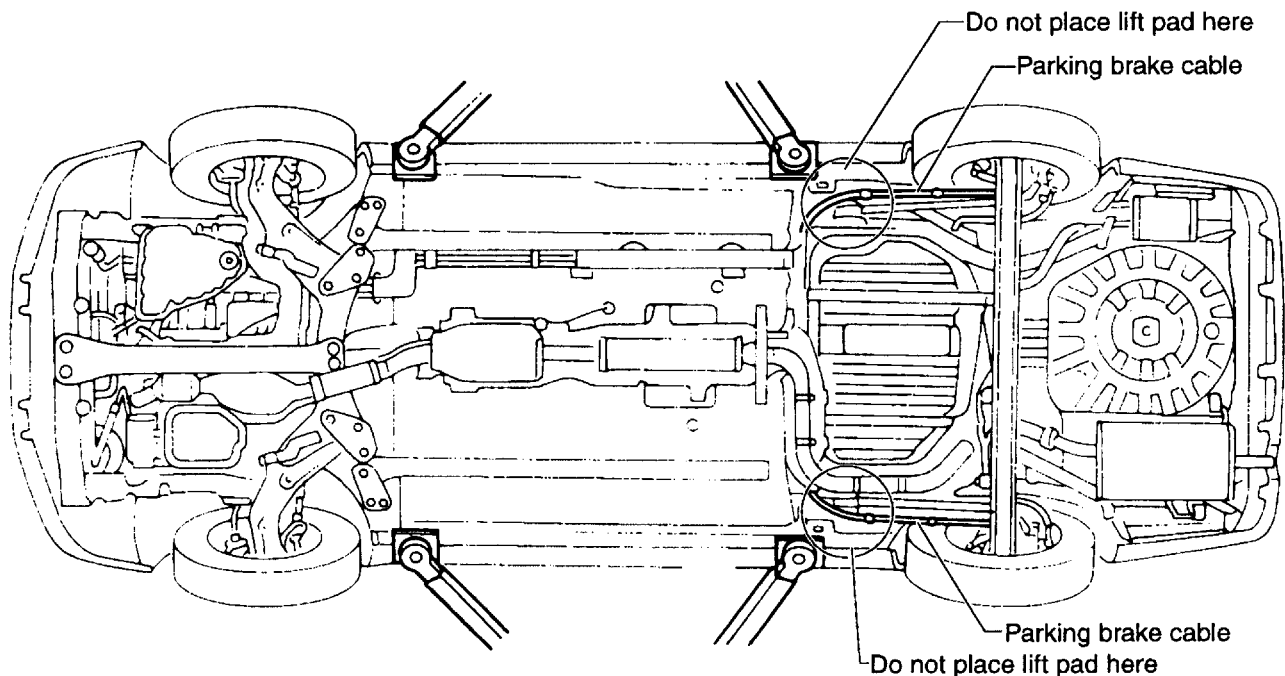
If the hoist arm is improperly positioned on the rear trailing arm/mount area of a 1995-97 Maxima, the parking brake cable can be torn or pinched.

If this occurs, difficulties with the parking brake cable operation may result.

To eliminate this possibility, use proper rear lift locations as shown.

CAUTION: Put the sill in the groove of the lift pad to prevent the sill from deforming. If the pad does not have a groove, prepare a suitable attachment with one. For 1995 and 1996, refer to the service manual pages GI-37 and GI-39. For 1997, refer to the service manual pages GI-39 and GI-41.
