# SERVICE CAMPAIGN BULLETIN

NTB98-073a

## VOLUNTARY SERVICE CAMPAIGN 1996 MAXIMA MALFUNCTION INDICATOR LIGHT (MIL) ISSUES

**CAMPAIGN I.D.#:** P8132 & P8152

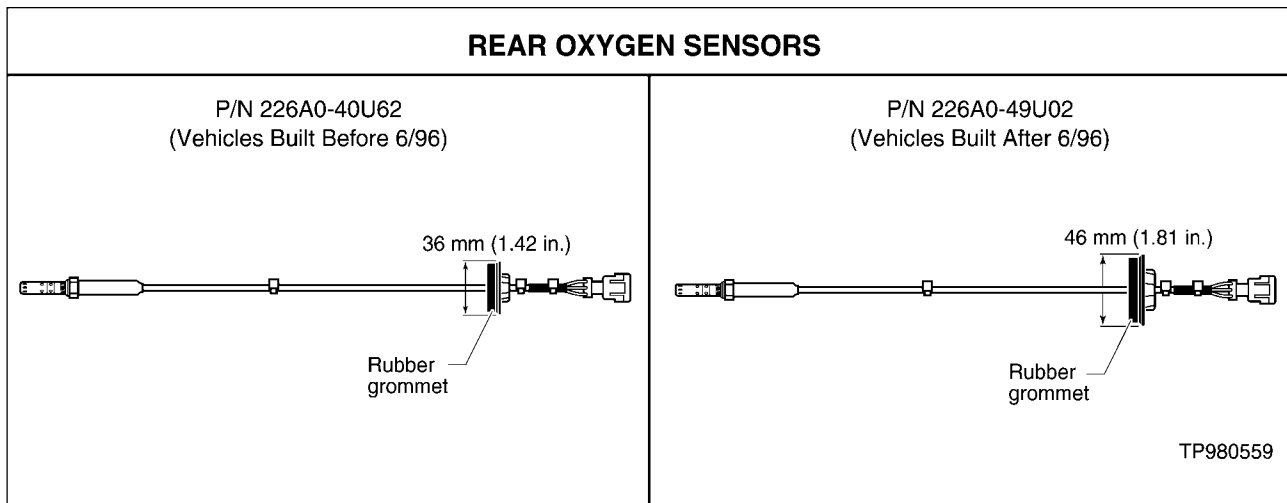
Figure 1

**NOTE:** There is a difference between the rear oxygen sensors depending on the production date of the vehicle. The difference is the size of the rubber grommet (see Figure 1).

1. Determine the production date of the vehicle.
  - A. If the vehicle was produced before 6/96, install oxygen sensor kit P/N 22690-40U25 using the following steps.
  - B. If the vehicle was produced 6/96 or later, install oxygen sensor kit P/N 226A0-49U25 using the following steps.

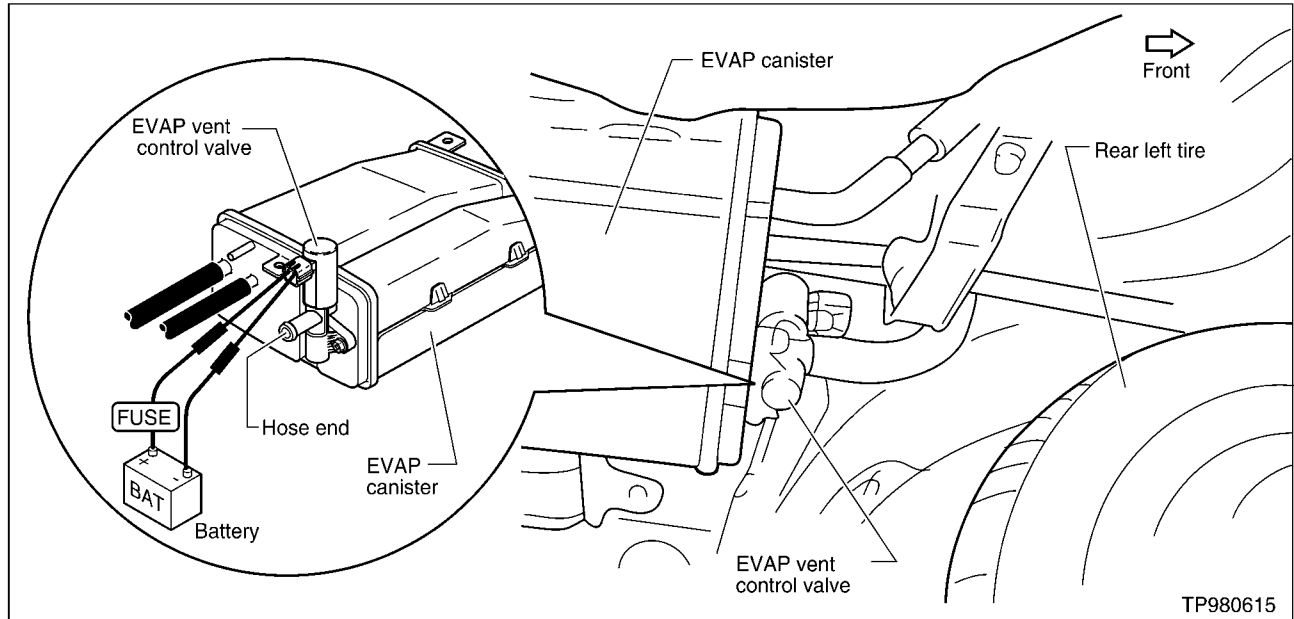
Figure 3

- B. While looking into the hose end of the EVAP vent control valve, disconnect the battery and make sure the air passage opens immediately (the valve should not stick closed).
- C. Look inside the valve hose end and make sure there is no corrosion or rust on the metal shaft. Also verify there is no sand, spiders or other debris in the air passage.
- D. Replace the EVAP vent control valve if it fails one or more of the above checks. Refer to “EVAP Components Information” to determine which EVAP vent control valve to install.

- 1. Inspect the EVAP vent control valve as follows:
    - A. Apply battery voltage to the vent control valve and look into the hose end of the valve to make sure the air passage closes (see Figure 3).
- NOTE:** The valve must function (click) on the first application of battery voltage.
